DAMAGE PREUENTION TRAINING CONFERENCE 2023 • FRENCH LICK, IN

IN ORBIT –

Routine Infrastructure Monitoring Solutions from Space are Taking Off!!

Orbital Sidekick

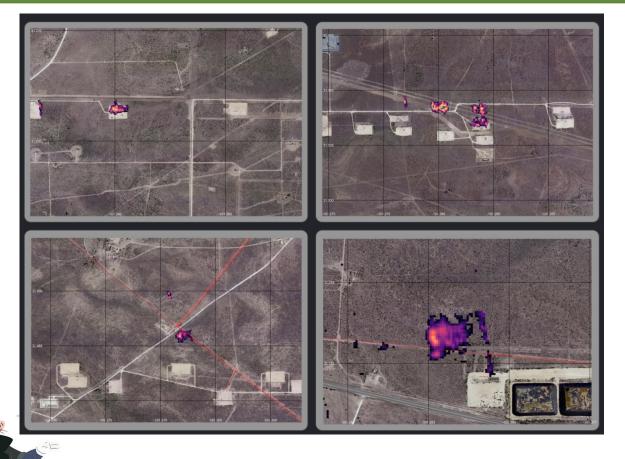
Alerts									
20220727_01_02_008	20220727_01_02_002	20220727_01_02_006	20220423_01_01_21	20220423_01_01_22					
Leak Detection Liquid Hydrocarbon	Leak Detection Liquid Hydrocarbon	Leak Detection Liquid Hydrocarbon	Leak Detection Gas Plume	Leak Detection Gas Plume					
20220423_01_01_24	20220423_01_02_03	20220423_01_02_09	20220423_01_02_14	20220423_01_02_23					
Leak Detection Gas Plume	Leak Detection Liquid Hydrocarbon								
20220423_01_02_36	20220423_01_02_57	20220423_01_02_58	20220423_01_02_60	20220423_01_02_64					
Leak Detection Liquid Hydrocarbon

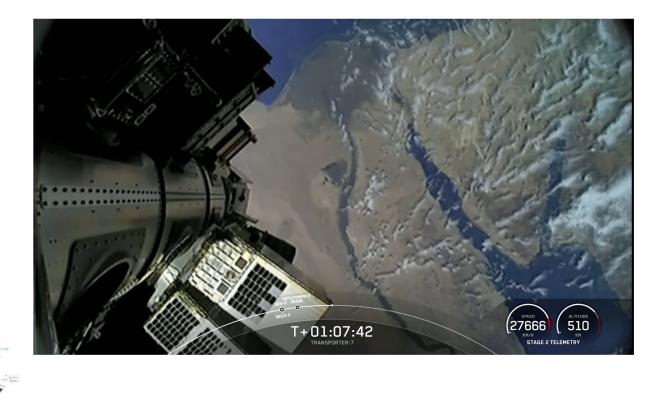
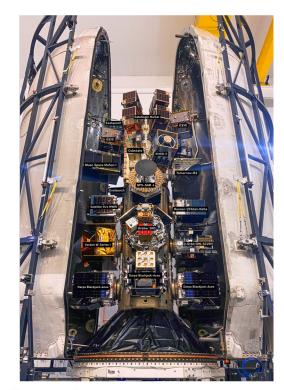
Deploying the Next Generation of Sensors into Orbit

DATE	ORBIT	PERIGEE	APOGEE	SEMI-MAJOR AXIS ALT.	INCL.	AVAILABILITY	
04/2024	LE0			550-605km	45.4±0.1	1/4, 1/2, Full	\rightarrow
11/2024	LE0			550-605km	45.4±0.1	1/4, 1/2, Full, XL	\rightarrow
02/2025	LEO			550-605km	45.4±0.1	1/4, 1/2, Full, XL	Minest
05/2025	LEO			550-605km	45.4±0.1	1/4, 1/2, Full	DAMAGE PREVENTION
